FAA Technical Center Atlantic City International Airport, N.J. 08405 Fracture and Fatigue Strength
Evaluation of Multiple Site Damaged
Aircraft Fuselages - Curved Panel
Testing and Analysis

January 1994

Final Report

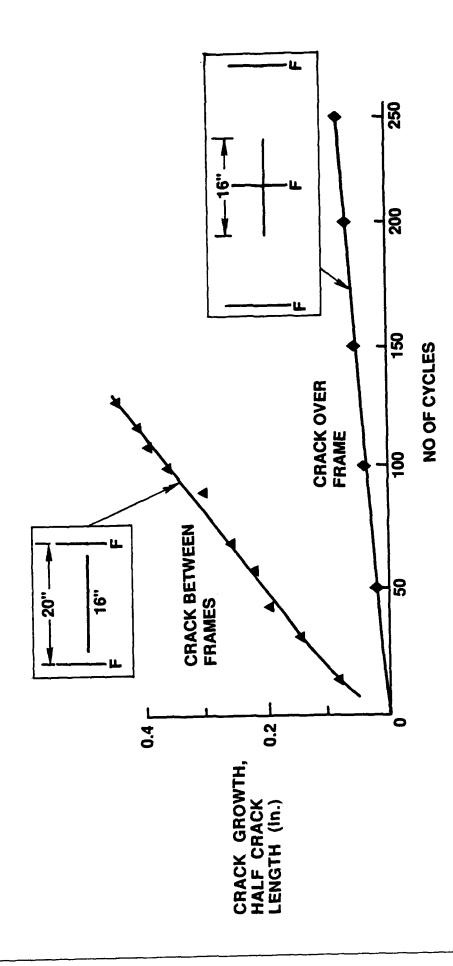
Figure 5-8. Fatigue Test Crack Growth Rate

Fatigue tests on the machine-cracked panel were conducted at a rate of 720 cycles/hr (0.2 Hz). Crack growth was monitored using a travelling microscope. Typical results are shown in Figure 5-8 for a crack over a frame and a crack between two adjacent frames. The stress intensity factor when the crack tip is near a frame is expected to be different from that when the crack tip is at mid-bay. Hence, the significant difference in the crack growth rates for the two cases.

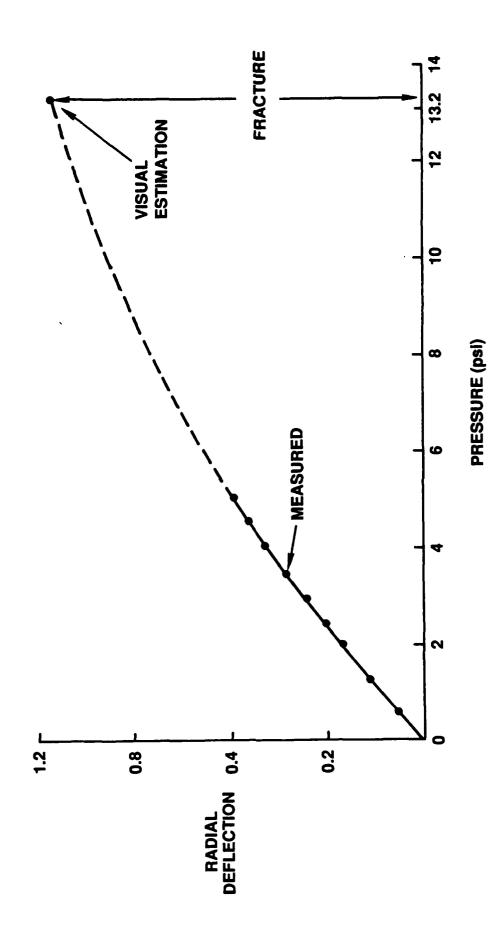
Figure 5-12. Fracture Test - Bulging at Crack Center

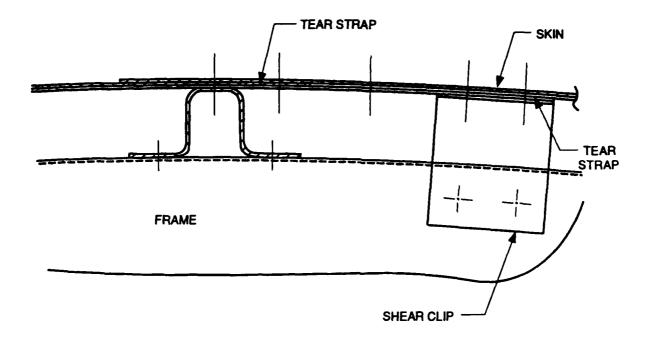
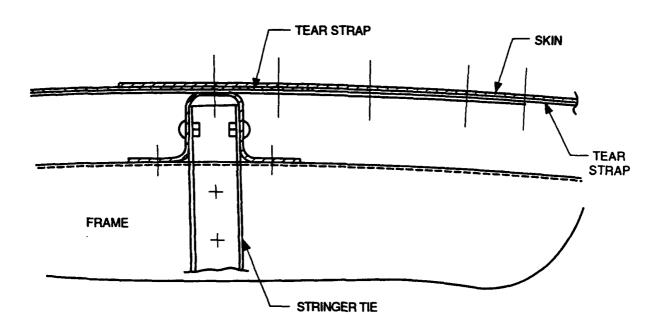
Figure 5-13. Skin Attachment to Frame

After about 5,000 cycles with pressure ranging from 1.0 to 8.6 psi, a fatigue crack started forming in the head of one rivet fastener which attached a shear clip to the skin (Figure 5-13a). All shear clips were replaced by "stringer ties" which are typical in commercial aircraft.

(a) SHEAR CLIP FOR USE IN RESIDUAL STRENGTH AND LOW CYCLE FATIGUE ONLY

(b) STRINGER TIE FOR HIGH CYCLE FATIGUE

Panels 3, 4, 6 and 7 were modified as a result of experience gained during fatigue testing of panel 7. The modification involved the replacement of all 30 shear clips with 36 U-shaped stringer tie brackets on the four panels. These brackets nest inside the stringers and are rivet attached to the stringer and frame webs. These modifications are shown in Figure 5-13 on page 63 as part of the discussion of testing results.

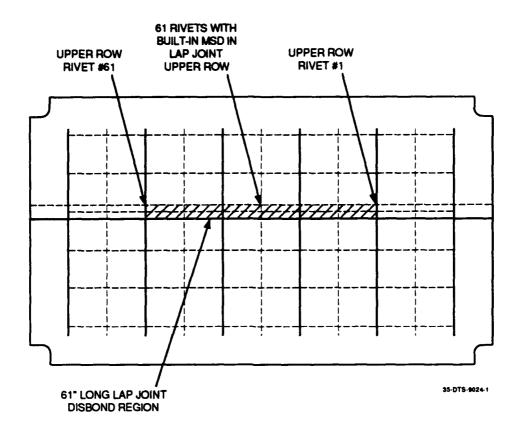
Figure 5-14. Panel Configuration and Initial Damage

The lap splice was fabricated without a bond for a 61-in. length and the top skin at the upper row rivet holes was prenotched to simulate MSD. After prenotching, countersunk rivets were installed according to standard practices. The notches did not extend beyond the rivet heads and hence were not visible from outside. At the inner skin surface, a 0.5-in. bead of silicone was applied covering the skin edge to prevent water leakage through the lap joint during the test. Figure 5-14 shows schematically the initial damage and the rivet numbering system.

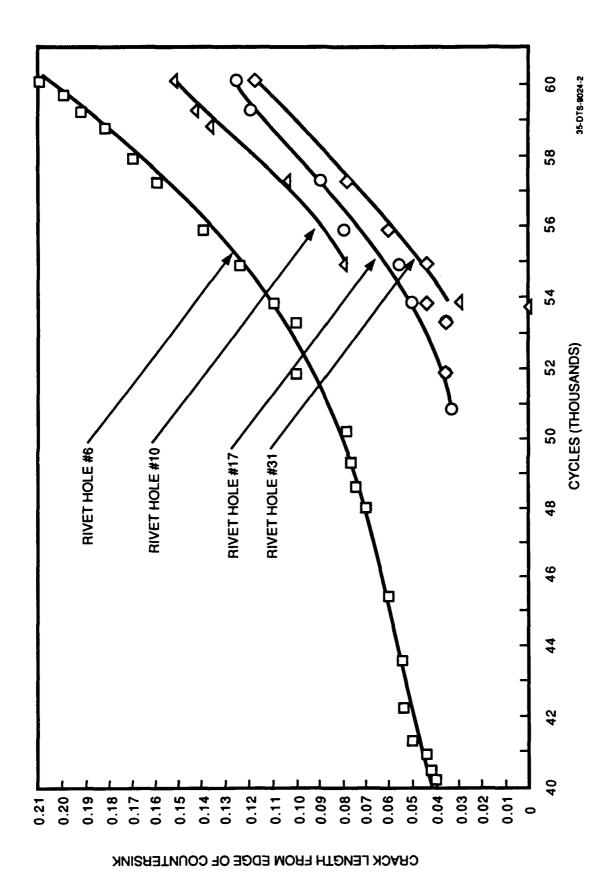
Figure 5-15. Crack Growth Data

Cracks grew at a total of 37 locations. Measured crack growth rates at several of these locations are indicated in Figure 5-15. From about 68,200 cycles, increasing water leakage was observed, which was attributed to cracks in the lower skin. At 68,300 cycles, a distinct noise was heard. The testing was stopped to observe the conditions of the bottom skin, which showed link-up of two ligaments at the lower lap joint rivet row. The test was continued for an additional 50 cycles, when the panel fractured in a catastrophic manner (Figures 5-16 and 5-17).

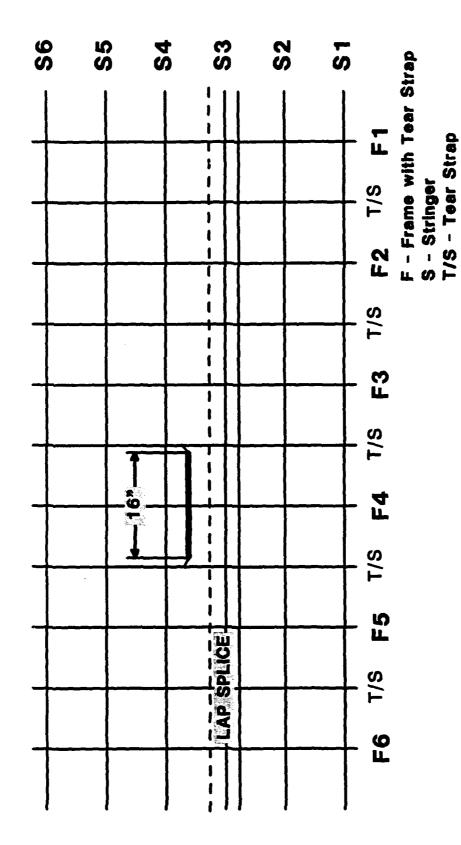
Figure 6-2. Initial Location of 16-in. Crack

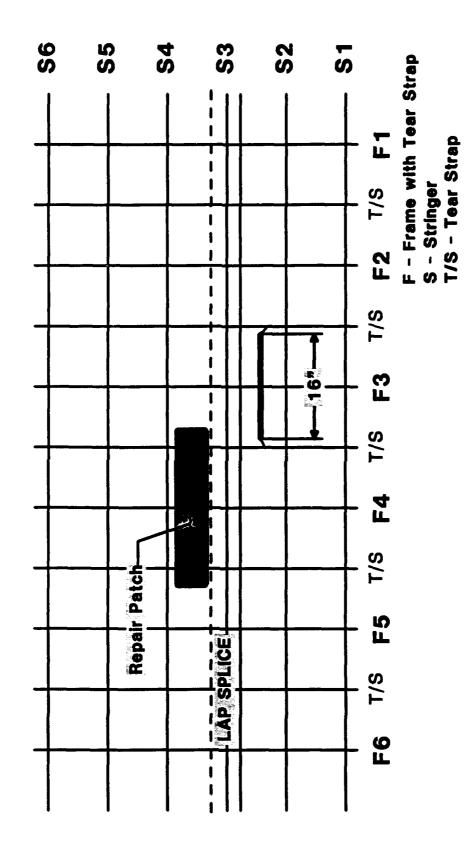
Figure 6-3. Initial and Final Locations of 16-in. Crack in Repaired Panel (Test No. 13)

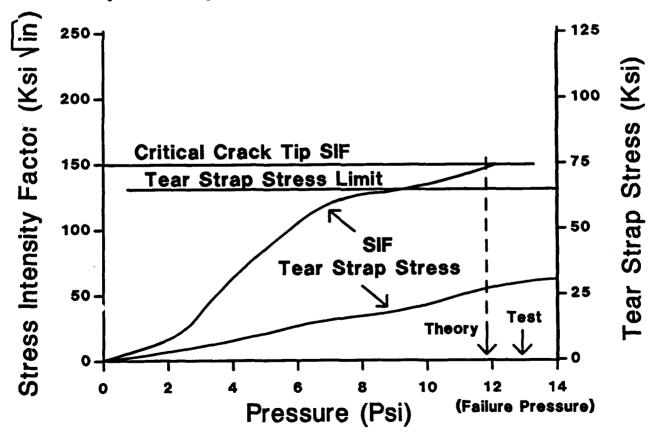
Figure 6-5. Analytic Predictions for 16-in. Crack

Analytic modeling using NISA-386 software has been carried out to determine the stress intensity factors (SIF) and stress levels in the tear straps. Details of modeling and evaluation of SIF using singular elements are presented in Section 8. The results for the case of a 16-in. skin crack in this fuselage structure with tear straps is shown in Figure 6-5. The computer model predicts the crack tip SIF reaching the critical limit [which is approximately taken to be at 150 Ksi √in. for 0.04 in. thick AL 2024-T3 (1)] at about 12 psi which is close to the average value of 13.0 psi for the two tests. No tear strap failure is predicted or observed in the test.

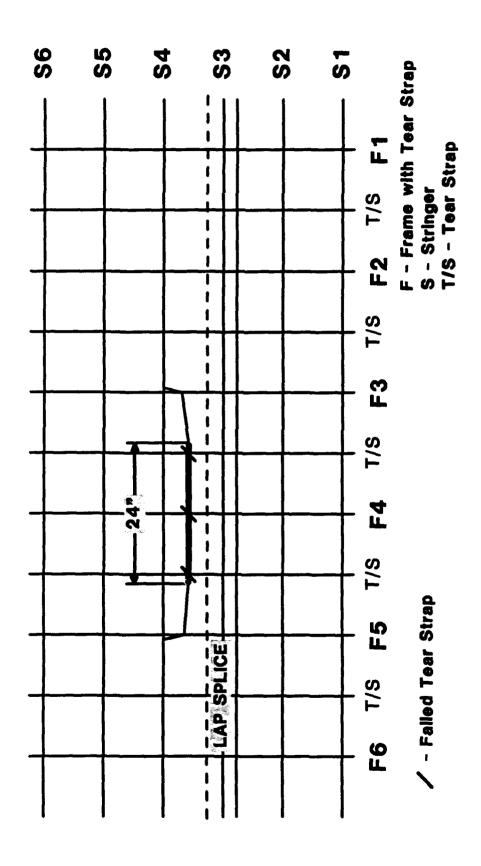
A 24-in. long skin crack was cut symmetrically over a frame, as shown in Figure 6-6. Again, care was taken to ensure no initial damage to the tear straps. The pressure level was increased at the rate of 1 psi/sec. Pressure at panel failure was found to be 9.6 psi. The crack extended and turned at the nearest frames, F3 and F5, as shown in Figure 6-6 and 6-7. "Flapping" of the damaged skin portion did occur. The underside view of the damage with broken straps is seen in Figure 6-8.

Figure 6-6. Panel with 24-in. Initial Skin Crack

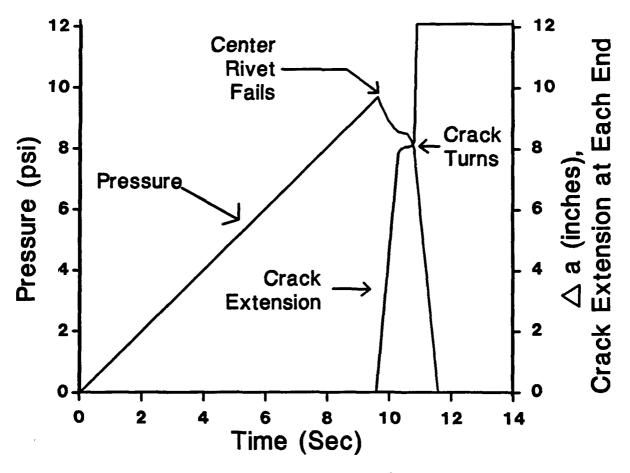
Figure 6-9. Pressure Variation and Crack Growth

Pressure variation and crack growth with time are shown in Figure 6-9. The panel failure event was recorded using a video camera. Review of the video in slow motion has allowed us to identify the various failure mechanisms. These are presented schematically in Figure 6-10. Again, the center rivet failed first. Mid-bay tear straps then failed in tensile fracture, increasing the stress intensity levels at the crack tips and thus causing fast skin fracture. As the crack grew to the nearest frames, F3 and F5, the center tear strap at F4 failed. The crack turned at the frames, as one would expect in the ideal situation, causing decompression. No damage to frames occurred.

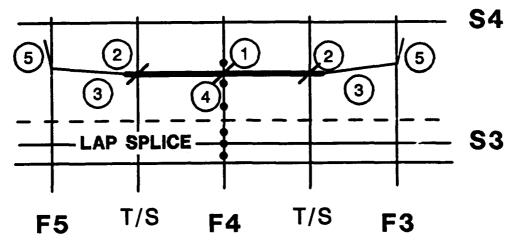
Figure 6-10. Failure Even. Sequence for Panel with Initial 24-in. Crack

- 1. Center Rivet Fails
- 2. Mid-Bay Tear Straps Fail
- 3. Crack Grows to Frames
- 4. Center Tear Strap Fails
- 5. Crack Turns

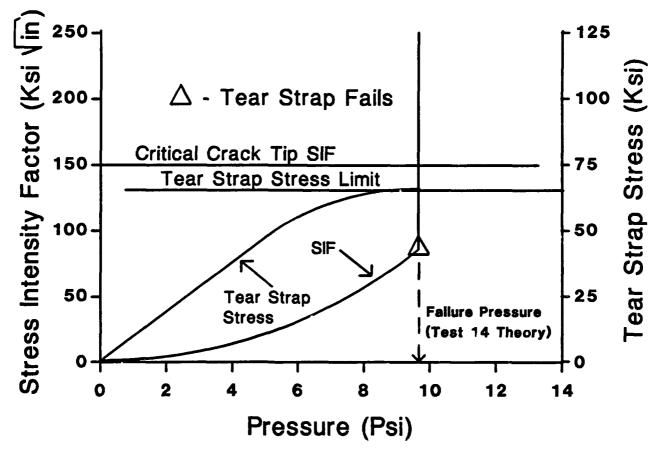
Figure 6-11. Analytic Predictions for 24-in. Crack

Analytic results from the computer modeling are presented in Figure 6-11. With increased pressure, the stress in the mid-bay tear strap (between frames) rises at a faster rate than the crack SIF and reaches are critical limit of 65 Ksi at about 9.5 psi. As stated earlier, the tear straps failed at this pressure level (9.6 psi). With broken tear straps, the model predicts an SIF well above the critical level and hence the skin crack propagation. Computer simulation has not been carried out beyond this failure mode.

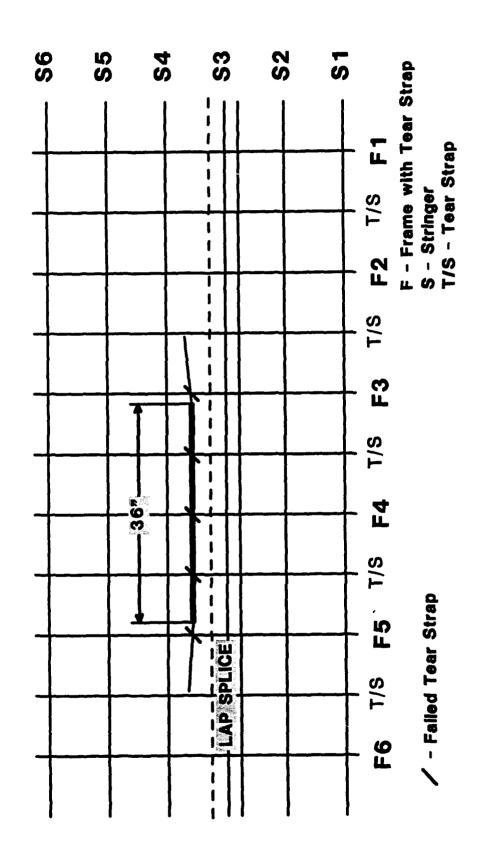
The close-up view reveals that the crack did not follow a straight line joining the rivet hole centers, but rather had a zigzag pattern. A similar pattern has been noted in some of the lap splice failures in the field. The zigzag path is attributed to the shear load present in service conditions; however, there was no shear load in the laboratory test.

Figure 6-12. Panel Fracture with Initial 36-in. Skin Crack

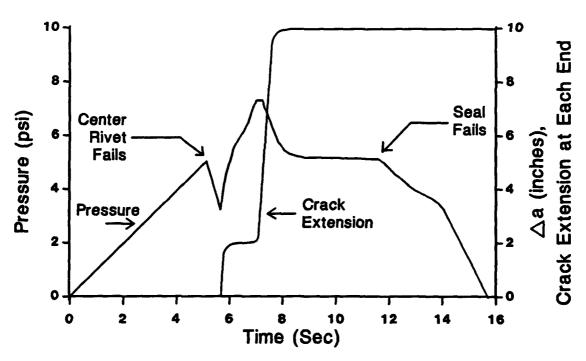
Figure 6-14. Pressure Variation and Crack Growth with Time (Panel with 36-in. Initial Crack)

Pressure variation and crack extension with time are shown in Figure 6-14. In this test, although the center rivet failed at about 5 psi, significant crack growth occurred at 7.4 psi which is considered to be failure pressure. Due to the failure of the seal, water pressure dropped significantly, but the skin crack continued to propagate for an additional 5 in. at each end of the crack.

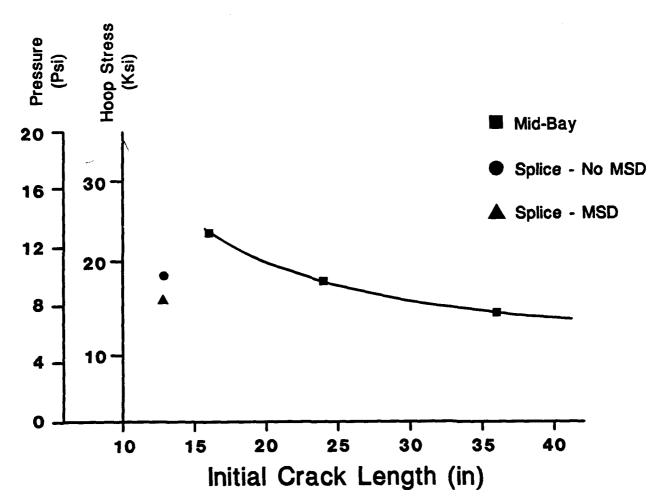
Figure 6-15. Test Results on Failure Pressures/Residual Strength

The residual strength data for panels with mid-bay cracks is summarized in Table 6-2 and plotted in Figure 6-15. The splice crack data of Table 6-2 are obtained from the following tests.

The data obtained for the splice cracks are plotted in Figure 6-15 along with the data for mid-bay skin cracks. From this figure, the splice crack is apparently more critical. However, this conclusion must be examined further. Recall that the lead splice cracks were centered on mid-bay tear straps, whereas the mid-bay skin cracks were centered on frames; thus the conditions were not identical in the two series of tests.

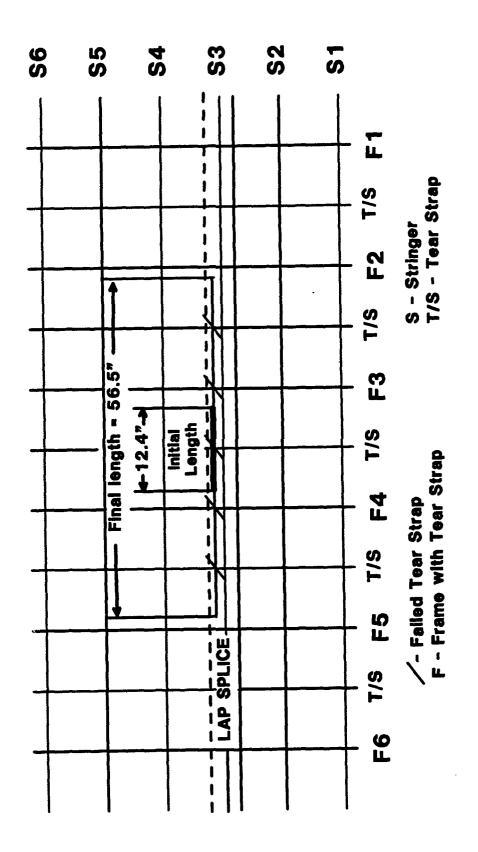
Figure 6-16. Panel with 12.4-in. Splice Crack (No MSD)

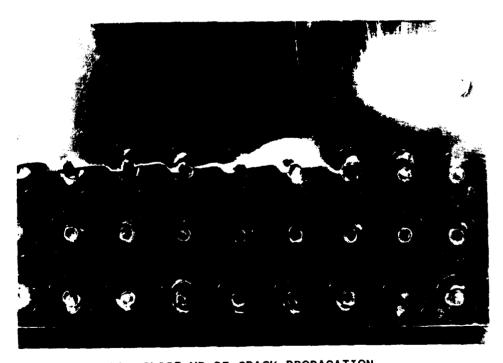
a) FRACTURED PANEL

b) CLOSE-UP OF CRACK PROPAGATION

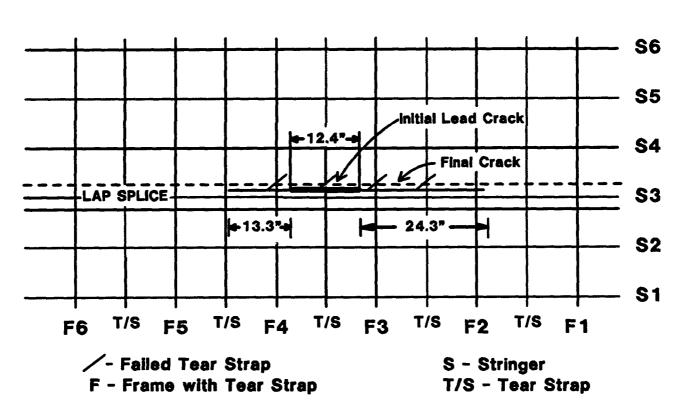
Figure 6-18. Panel with MSD

In this test, the top row of the upper skin lap splice joint had MSD at three rivet holes on one side and eight rivet holes on the other side of the lead crack which was kept at 12.4 in. as in the previous test (see Figure 6-18a for detail). The length of each small crack at the rivet holes was about 0.4 in. inclusive of one hole radius. In this test, panel fracture occurred at 8.5 psi, 2 psi less than in the previous case of the single lead crack with no MSD. The crack extended asymmetrically at the ends due to the initial asymmetric MSD, as shown in Figure 6-18b.

b) INITIAL AND FINAL DAMAGE

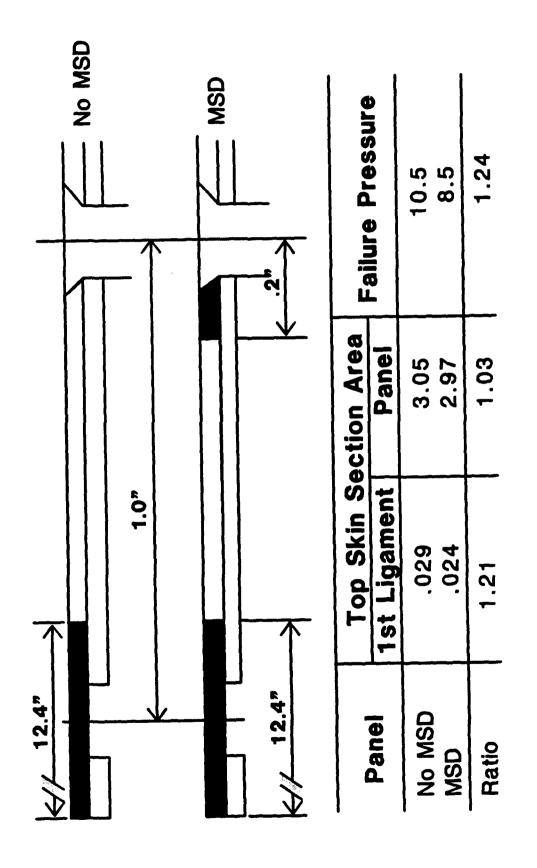
Figure 6-20. MSD Strength Reduction Correlation with Net Section Area

The reduction in panel residual strength due to MSD has been a concern and has been anticipated by Swift. No computer simulations have been carried out to determine the reduced strength under MSD. However, an elementary analysis has been performed based on the net section. Figure 6-20 presents the results of this analysis. The failure pressures for the two cases are approximately proportional to the net section areas of the **first ligament**. The ratio of the overall net section areas in the panels does not appear to predict the failure pressure ratio. However, these conclusions cannot be generalized without additional testing.

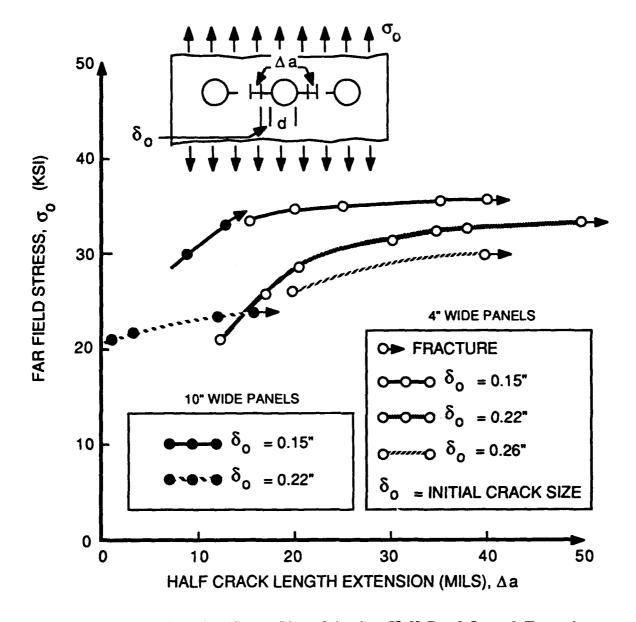
Figure 7-6. Far Field Stress Plotted Against Half Crack Length Extension

The far field stress (load/skin area without holes and cracks) at each load level is plotted against crack extension in Figure 7-6. It is seen that for the 10-in. coupon, with initial crack length of 0.22 in., a stress level of 23 Ksi causes a complete failure.

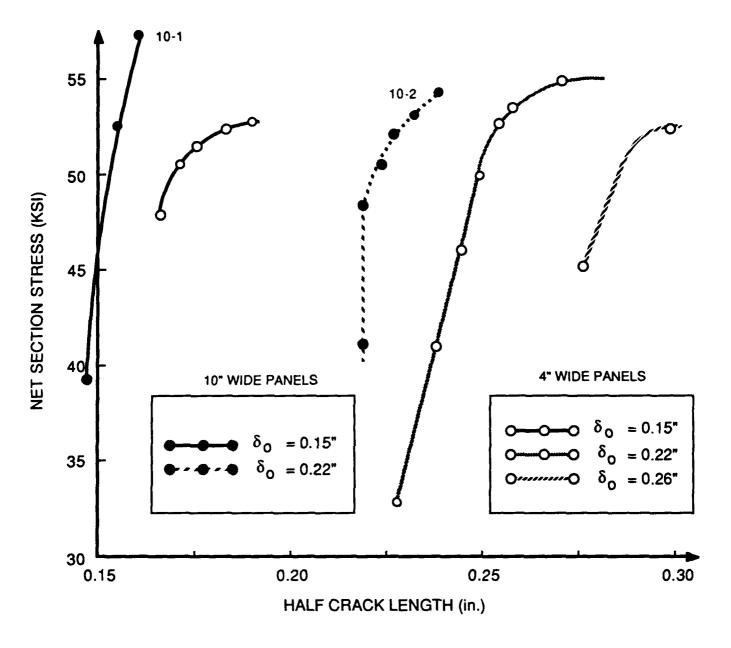
Figure 7-7. R-Curve Reduced Data Based on Net Section Stress

A plot of net section stress versus crack extension is presented in Figure 7-7. The stress is calculated after accounting for the incremental growth in the cracks. Four of the five coupons failed at a net section stress value between 53 and 55 Ksi. An average of 54 Ksi can be used in the criterion for MSD linkup based on the net section stress. Tensile tests carried out on specimens of this material gave a yield stress of about 49 Ksi and an ultimate of 67 Ksi as shown in Figure 7-8. As one would expect, the net section stress for fracture falls between these limits.

Realizing that the majority of the simulated MSD in coupons were saw cut and not fatigue originated, the limiting net section stress for the aircraft panels with fatigue cracks could be even closer to the material yield stress rather than the 54 Ksi quoted earlier. This statement needs to be verified by more rigorous experiments in the future.
